# Ancient Akrotiri Project

# Dreamer's Bay Underwater Survey, 2018

## *Interim Report*

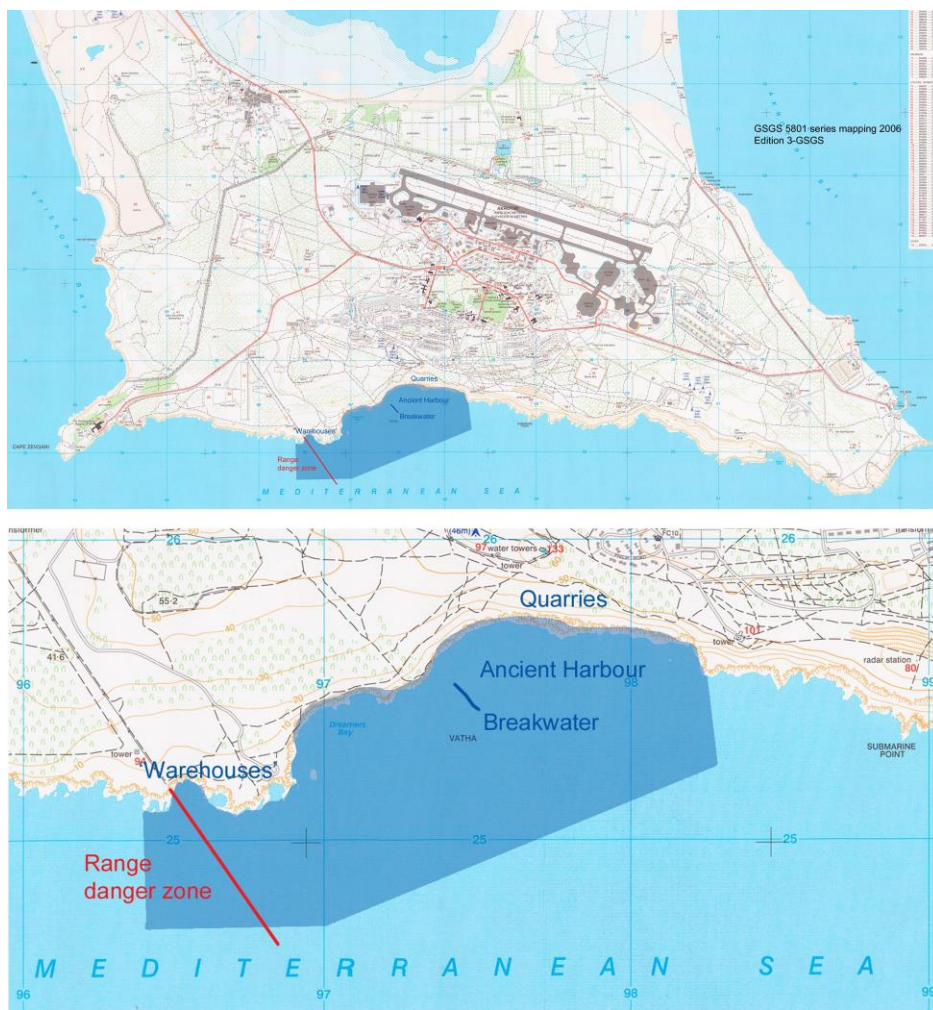
Figure 3: Underwater and shoreline survey work area conducted at Dreamer's Bay, September 2018. Large ruled squares are 1km on a side.

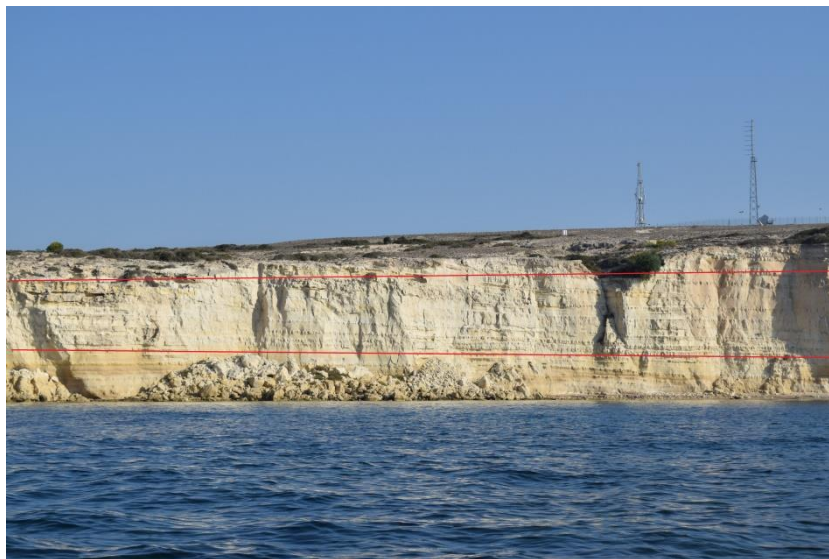
includes clastic deposits in the form of gravels, sand and silt. The same stratigraphy appears in the area where the coastal research was conducted in Dreamer's Bay (Figure 9).

Figure 9: Coastal survey area. Yellow Marls of the Pakhna Formation on the base, gray and yellow siltstones with inlays of sandy marls of Nicosia Formation in the middle part of the section and Fanglomerate with gravels and sands on top, covered by Aeolian sediments (photo by Miltiadis Polidorou, 2018).

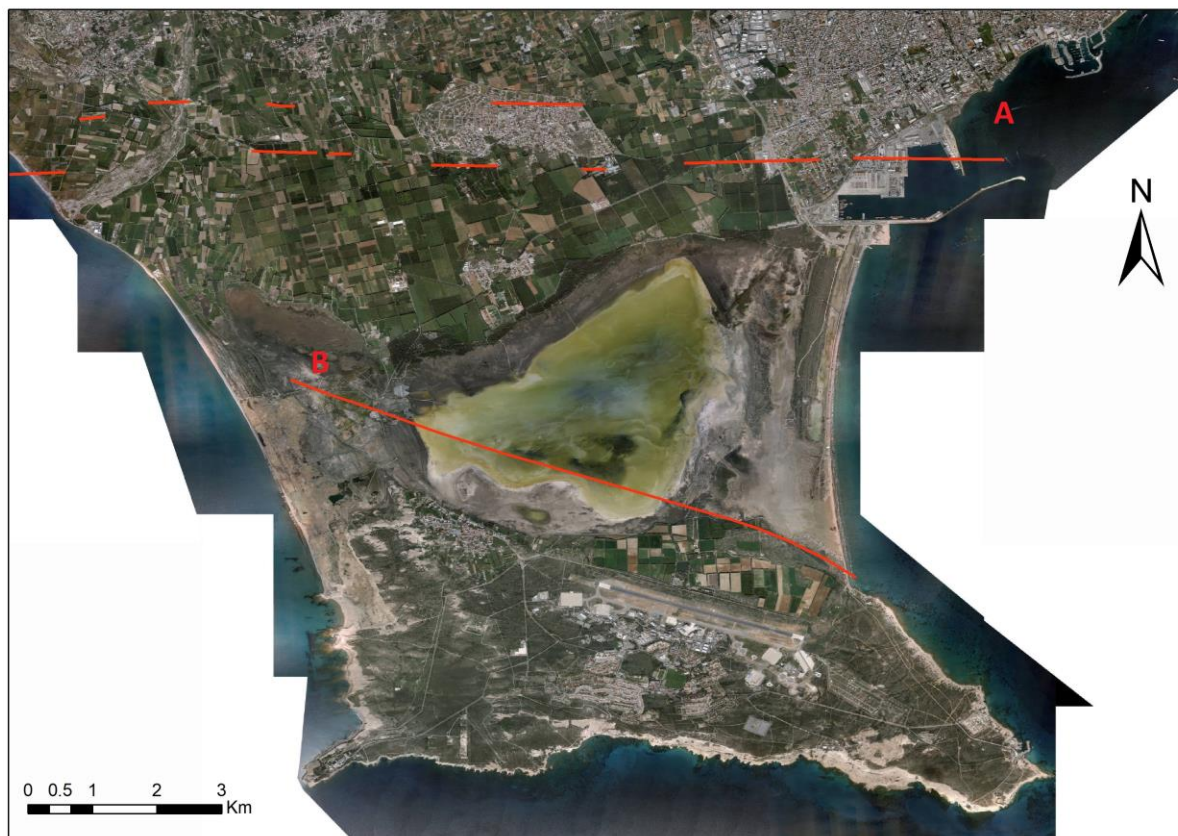
**General Tectonic Settings:** At Akrotiri Peninsula two main sets of Quaternary faults are identified (Figure 10). The first set of faults is orientated E to W, Left-lateral strike-slip faults with a vertical component are located towards the north of the peninsula (Fault A). The second set of faults have a NW to SE orientation, strike-slip faults with vertical component, and are located in the centre of the peninsula (Fault B). The impact of the faults is creating a horst- graben- horst type of geology to the topography in which the northern and the southern part of the peninsula is uplifting faster than the central part of the peninsula. This tectonic action is primarily responsible, along with Holocene rising sea-level, for the creation of the lagoon at the centre of the peninsula.

*Figure 10: Active Quaternary Faults. A. Left-lateral strike-slip faults with vertical component orientated E-W, B. Strike- slip fault with vertical component orientated NW-SE (Geoter, 2003)*

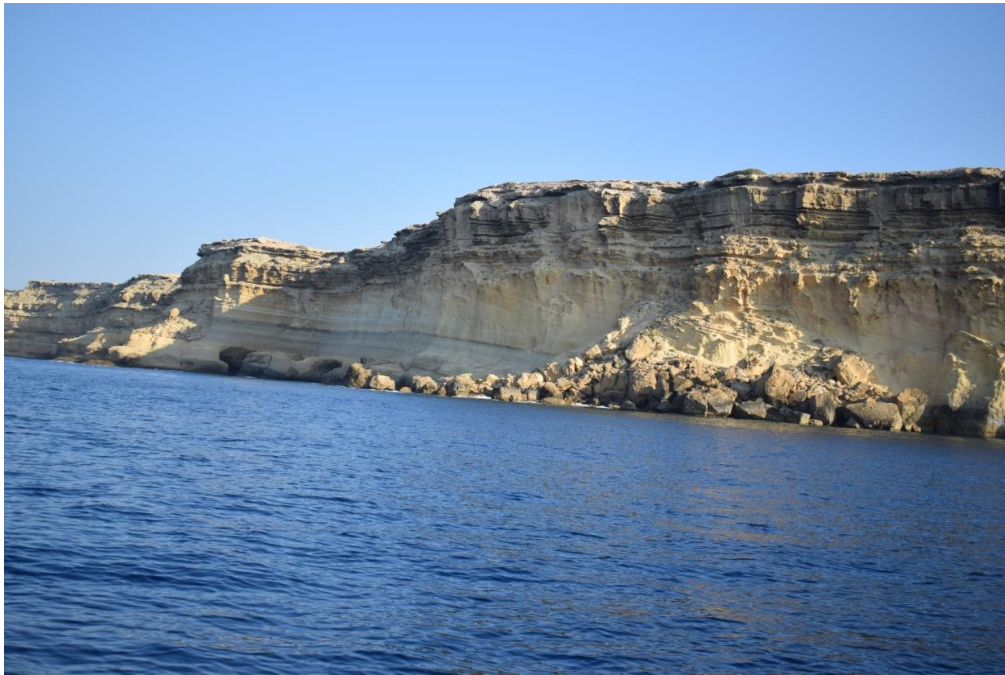
**Coastal Geomorphology:** The site of the survey is located at the south of the peninsula, east of Dreamer's Bay archaeological site. The main geomorphological features consist of steep cliffs with evidence of sub-aerial processes which includes mass movement and weathering of the cliffs. Also, there is strong evidence of high rates of coastal erosion in the form of Hydraulic action, Corrosion, Attrition and Abrasion (Figure 11). Not very well preserved notches are present indicating a gradual uplifting of the area (Figure 12). The notches were unable to be dated because of lack of biological or other indicators. At the seabed were

identified stumps and evidence for previous landslides were noted, which are the result of the cliff undercutting by wave action.

*Figure 11: High slope cliffs evidence of sub-aerial processes including mass movement & weathering*

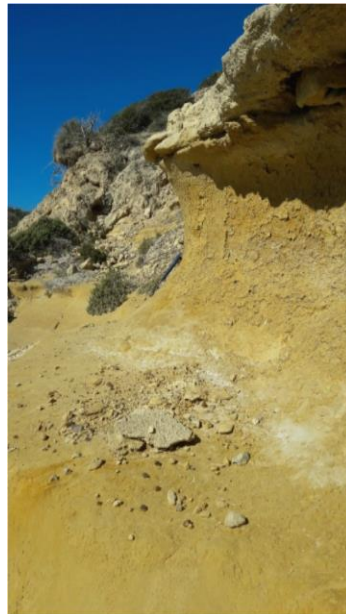
*Figure 12: Uplifted notch*

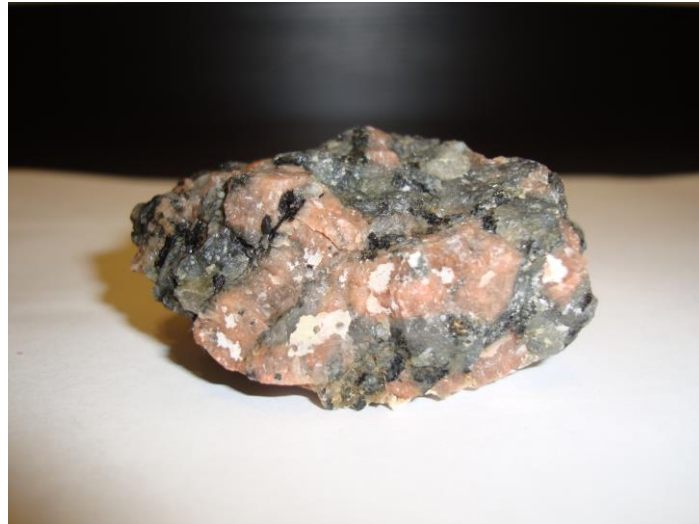
Four samples from the building stones were also taken from the breakwater (see Figure 13). Under the stereoscopic microscope the material of the building stones seems to be consistent with calcareous marls and sandstone which can be located in the nearby surrounding cliffs and quarries. All the samples will be chemically analysed by an XRF analyser. This analysis will provide information which can be used to identify the quarries that provided the building stones. One rock sample was retrieved from a submerged column which was coarse to very coarse grained, uniformly red/black/orange with a felcic composition. The rock mainly consists of feldspar, quartz, mica and amphiboles and has a granular phaneritic texture which is typical of Aswan Granite (Figure 14)

*Figure 14: Fragment of submerged column identified as Aswan Granite.*

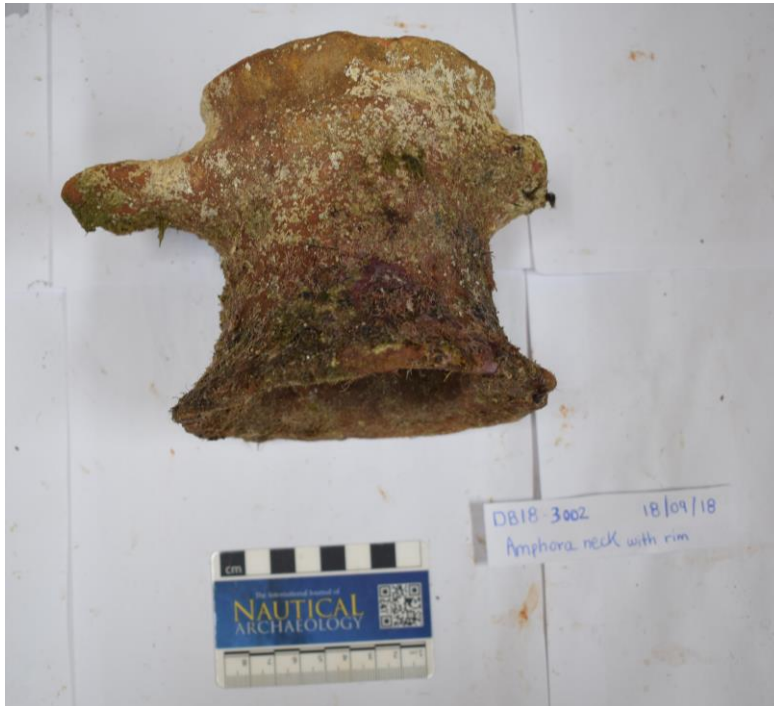
*Figure 22: Pottery fragments recovered from the seafloor on eastern side of the breakwater*

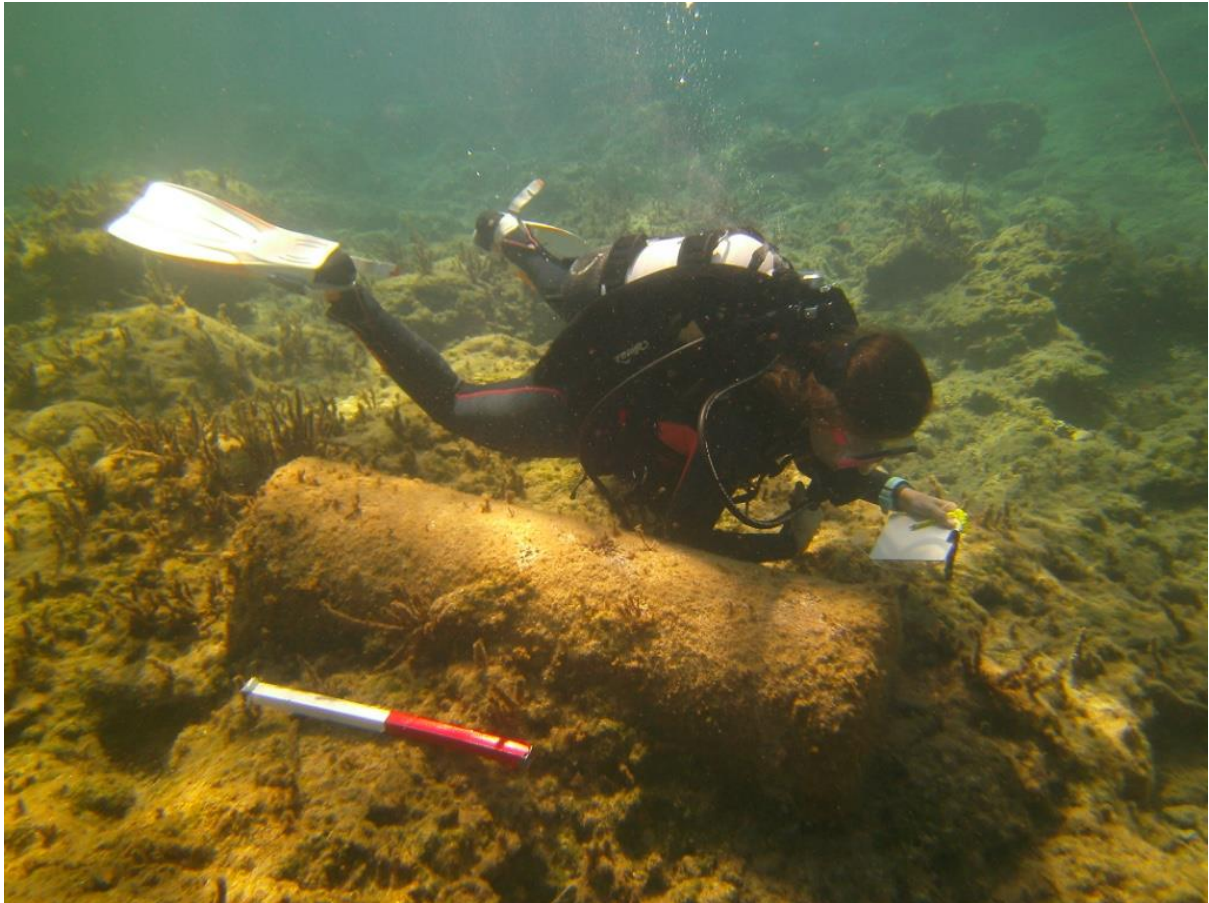
*Figure 25: Marble column on the seabed. (L. Blue)*
