Ancient Akrotiri Project

Dreamer's Bay Underwater Survey, 2019

Interim Report

The Breakwater survey - Lucy Blue and Miltiadis Polidorou

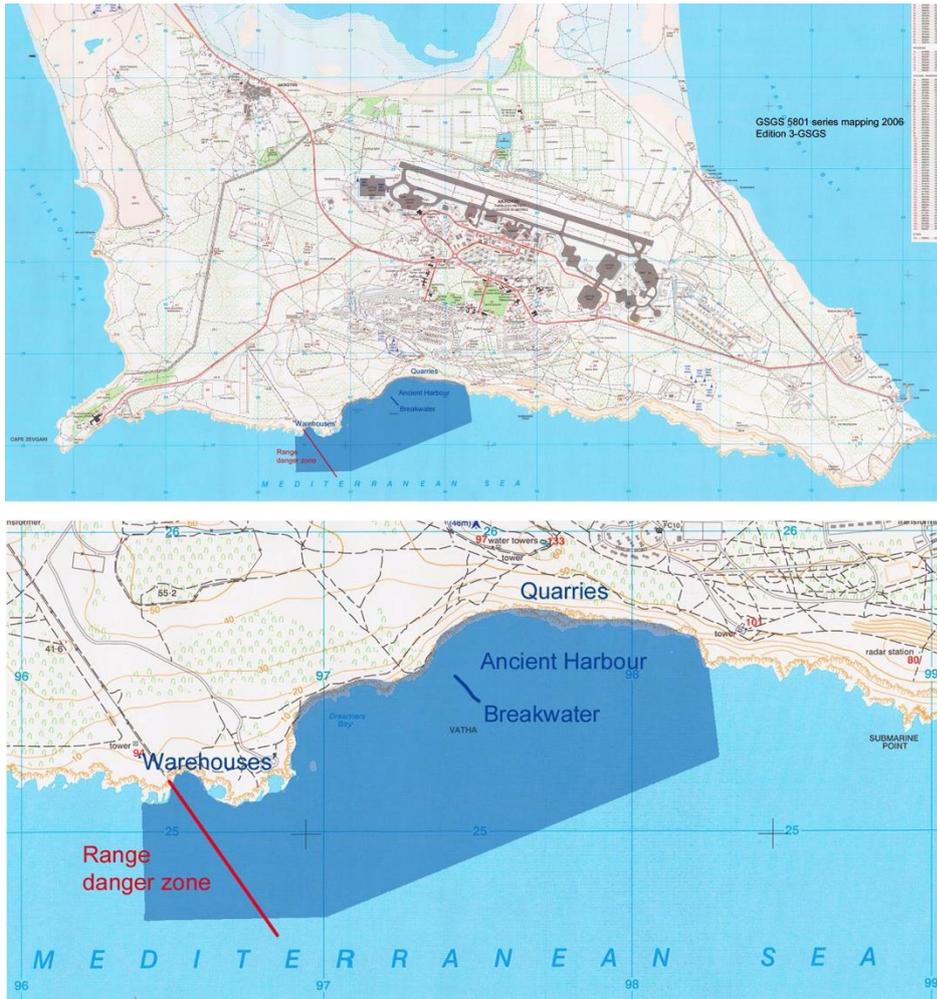
Figure 2: Underwater and shoreline survey work area conducted at Dreamer's Bay, September 2019. Large ruled squares are 1km on a side.

As noted, the submerged ancient breakwater currently extends over a distance of 135m roughly in a north-south alignment¹ perpendicular to the coastal cliff (Figures 2 and 6). The coastline to the north of the breakwater has been subject to coastal erosion and the end of the breakwater is now dislocated some 90m from the base of the cliff. Towards the southern, seaward end of the breakwater, the water depth increases and the feature widens out to 8.5-9m and extends to a greater depth underwater.

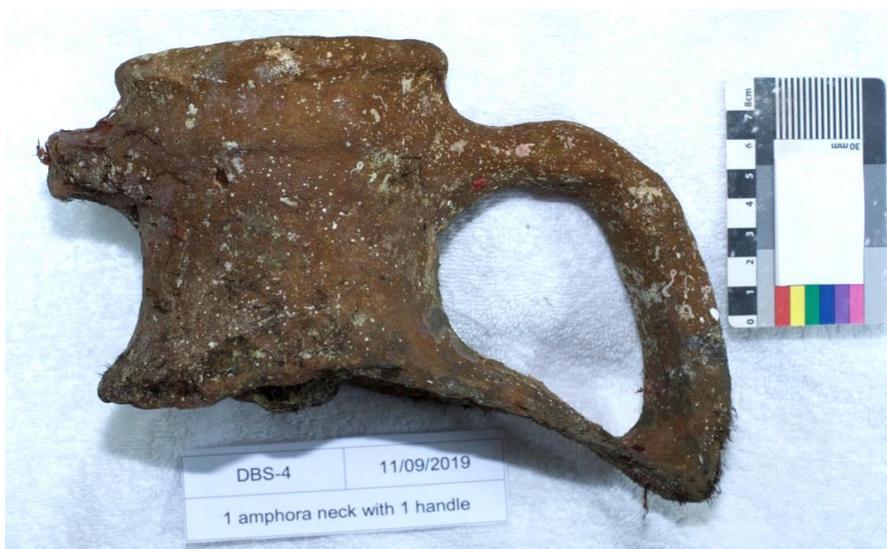
Figure 18: Neck and handle of LR13 amphorae recovered from the area of the shipwreck - DBS-4

During this survey, selected finds were lifted when archaeologists felt they were useful as chronological indicators or they could assist in defining the nature of this site. Nine finds were identified as amphorae (DBS-2, DBS-3, DBS-4, DBS-5, DBS-6, DBS-7, DBS-8, DBS-9, DBS-12). According to initial observation, four main amphora types have been distinguished in this selected sample: (1) the Gaza amphora (DBS-2), the basket handled amphora (DBS-12), LR1 amphora (DBS-6, DBS-9) and LR13 amphora (DBS-4, DBS-5, DBS-7). A sherd of a clay cooking pot (DSB-1) was also identified, while three bronze nails, one complete and the other two fragmentary, which were also lifted (DBS-10) (Figures 17 and 15). All finds were noted, described, photographed and declared to the Archaeological Museum of Episkopi. The area was extensively surveyed and the number of amphora shoulders and rims were counted equating to 781 in total, reflecting a fairly substantial cargo for ships of this period. Examples of the amphorae were lifted for further analysis, which is still on-going (Figure 18).
